AIRM Seminar
Camden Court Hotel
Wednesday 21st April 2010

Risk Management and the Problems Associated with the Presence of Pyrite Contained in Sub Floor Infill

Kevin Currivan, ACII
Eastern Regional Director
OSG Liability

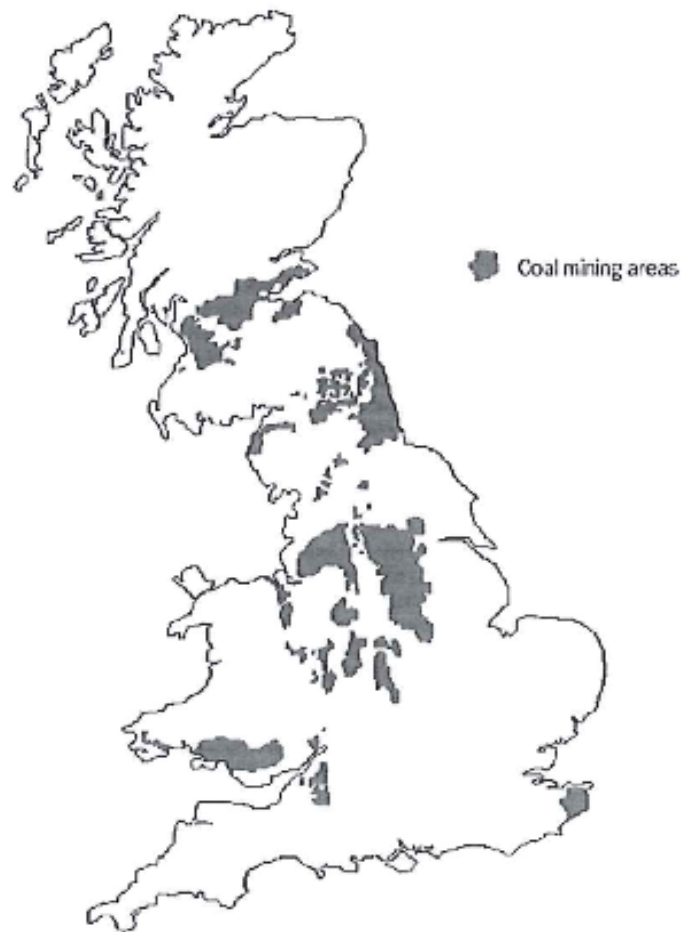
Map showing Coalfield areas of the UK. In and adjacent to these areas there has been widespread use of sulfate-bearing hardcore derived from burnt colliery spoil, furnace bottom ash and mineral processing slags.

- Affected areas in the UK are the English Midlands from Coventry to Birmingham.
- Also reported are areas in the North East of England from Doncaster northwards to Newcastle-upon-Tyne and the midland valley of Scotland between Glasgow and Edinburgh.

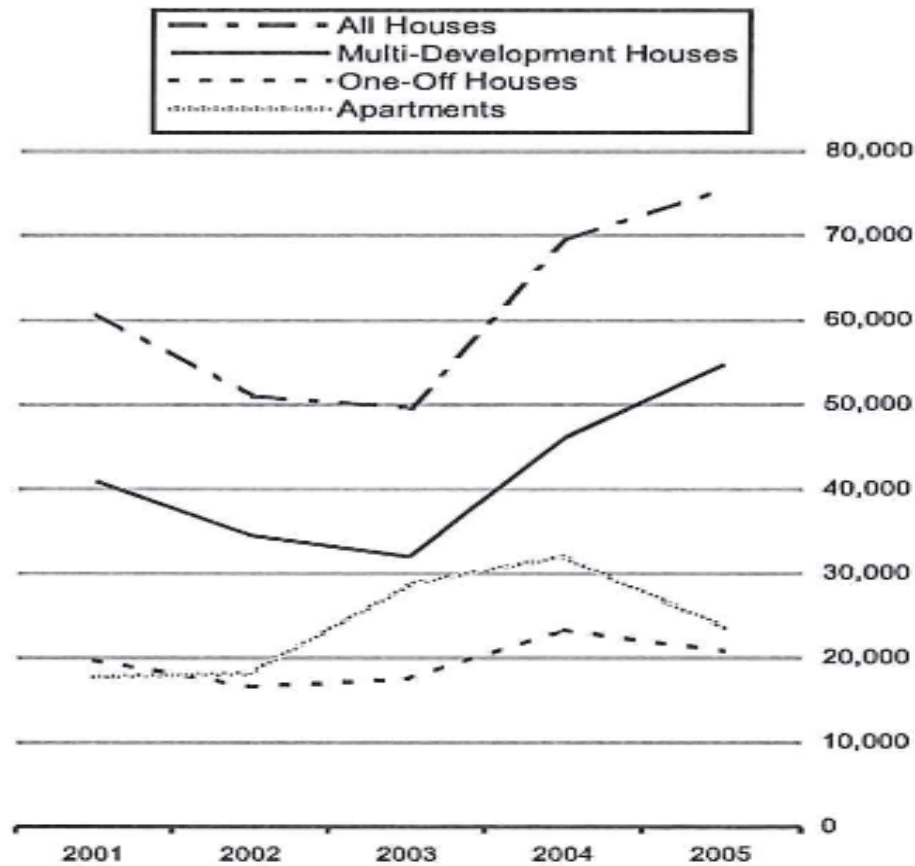
Number of Dwelling Units approved
classified by type of unit, 2001-2005

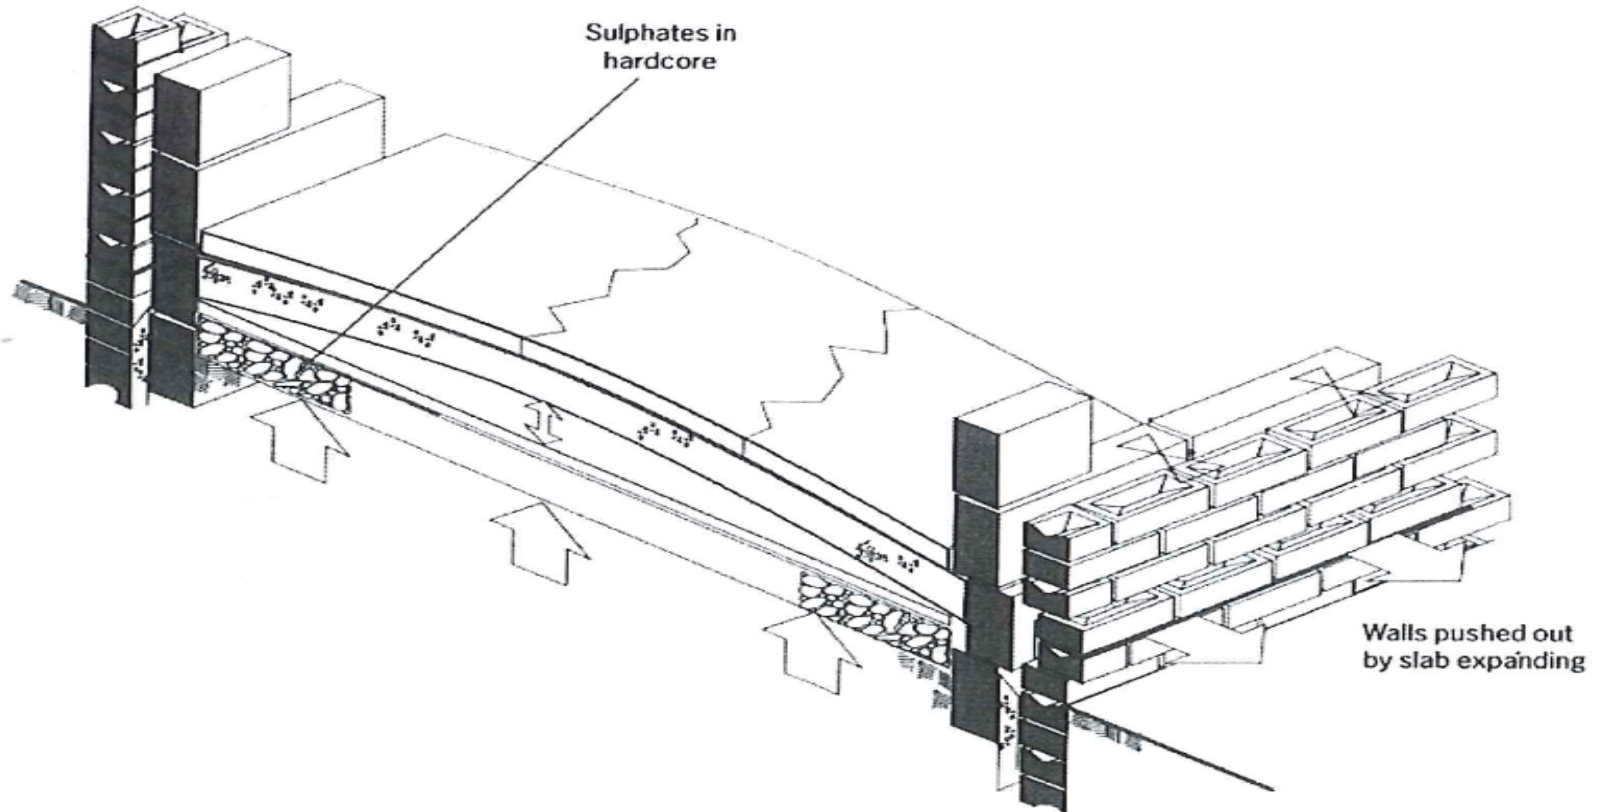
Doming and cracking of floor slab and outward displacement of walls

- As a consequence of the swelling and expansion of the infill damage has been seen mostly to the interior of properties.
- The swelling will take the route of least resistance and generally speaking this is upwards, affecting the concrete floor and internal walls.
- The rising walls can also be affected in some instances.

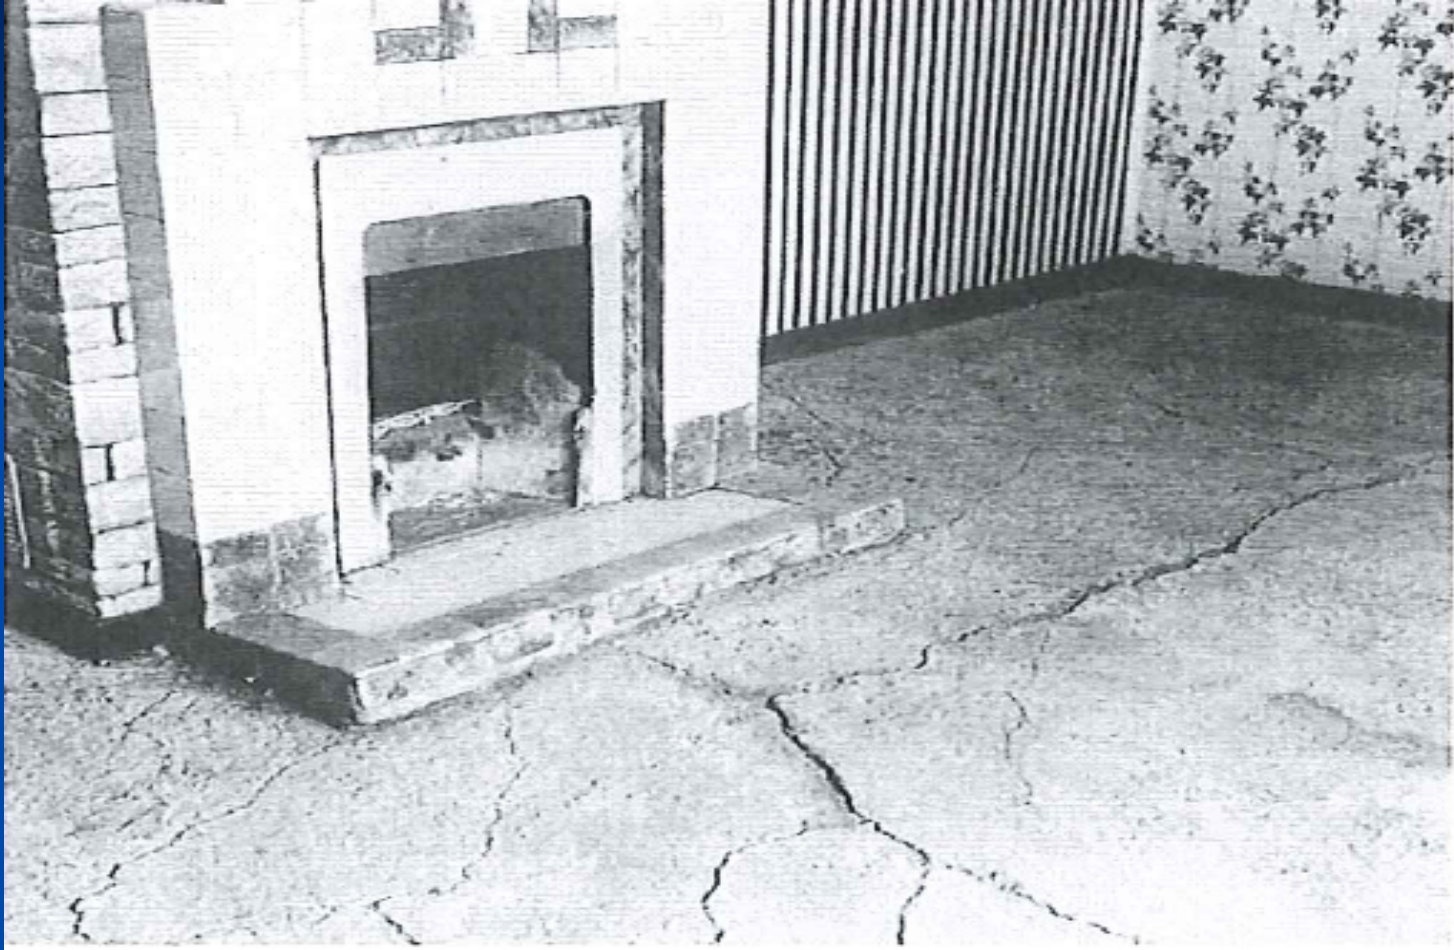
Distortion and cracking of the concrete floor slab caused by the expanding infill beneath

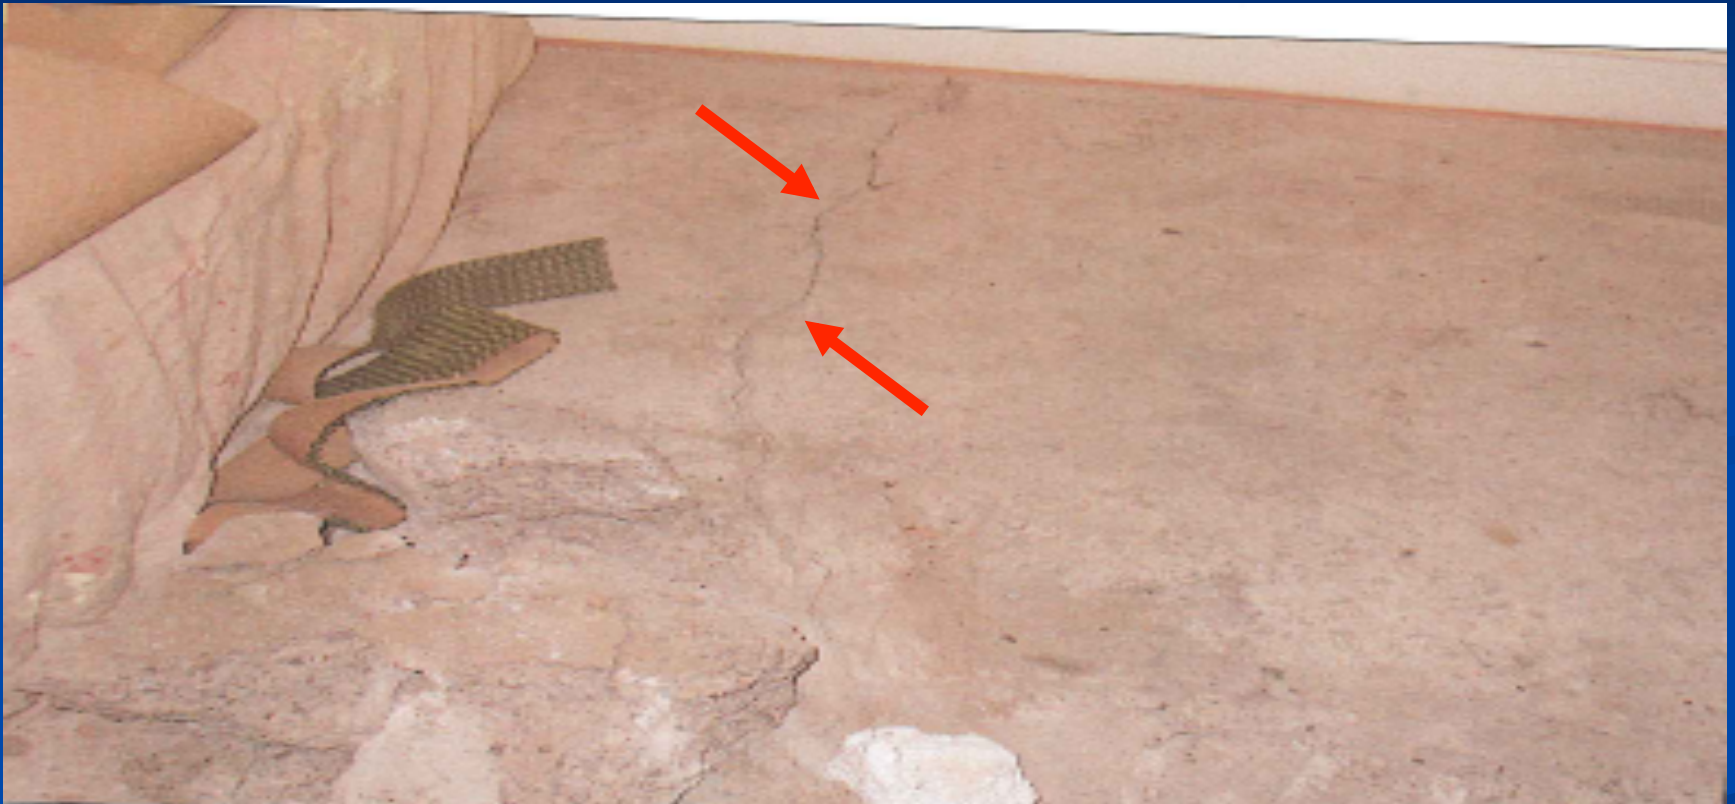
Photo shows evidence of concrete floor crack caused by expansion of infill

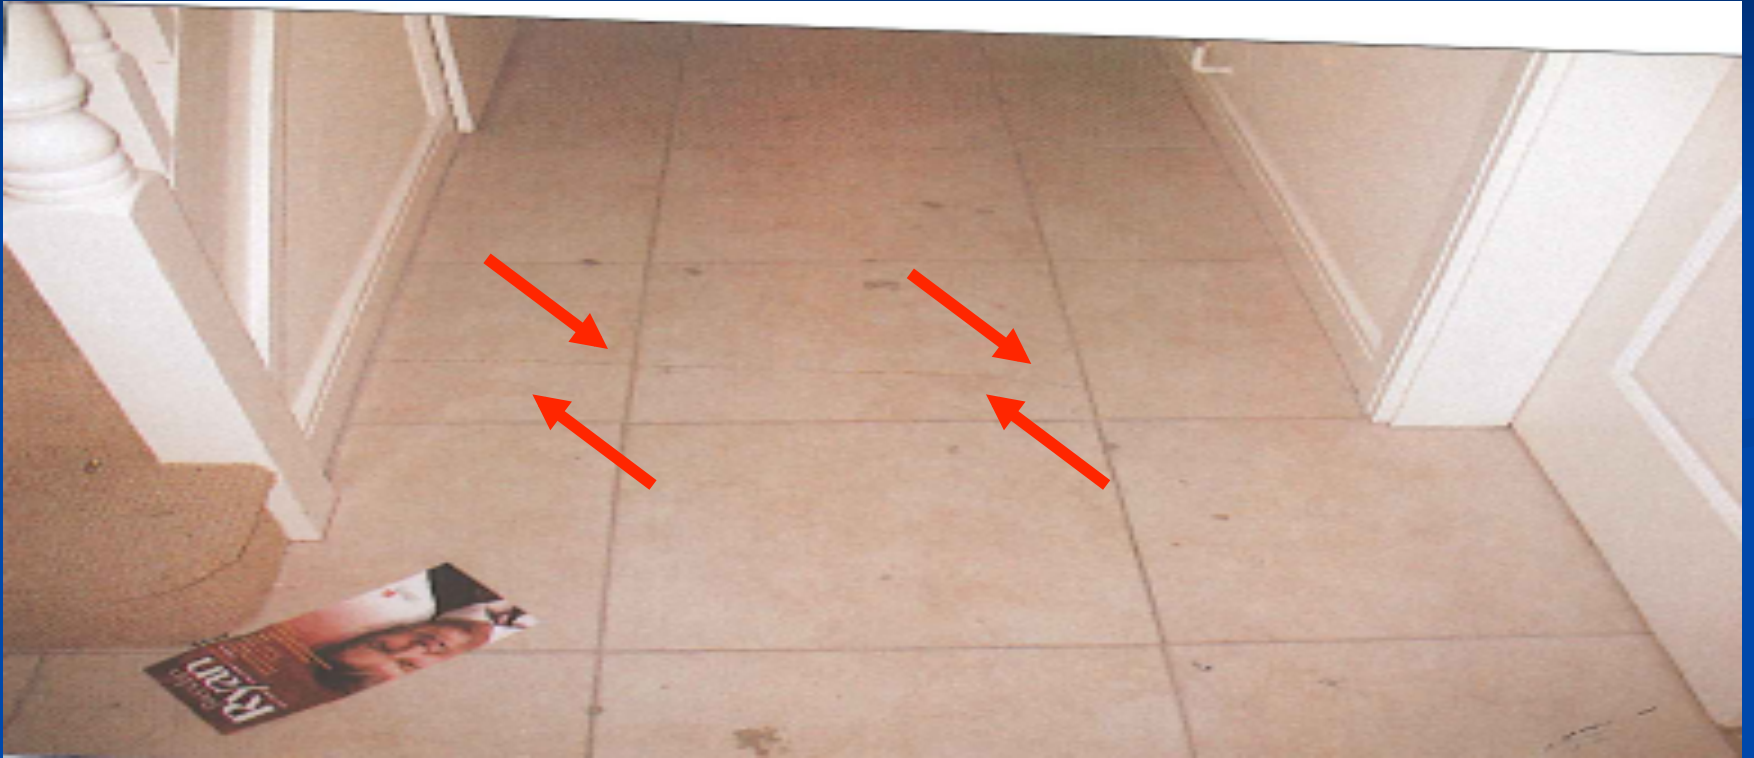
Photo shows cracking in tiles caused by swelling beneath

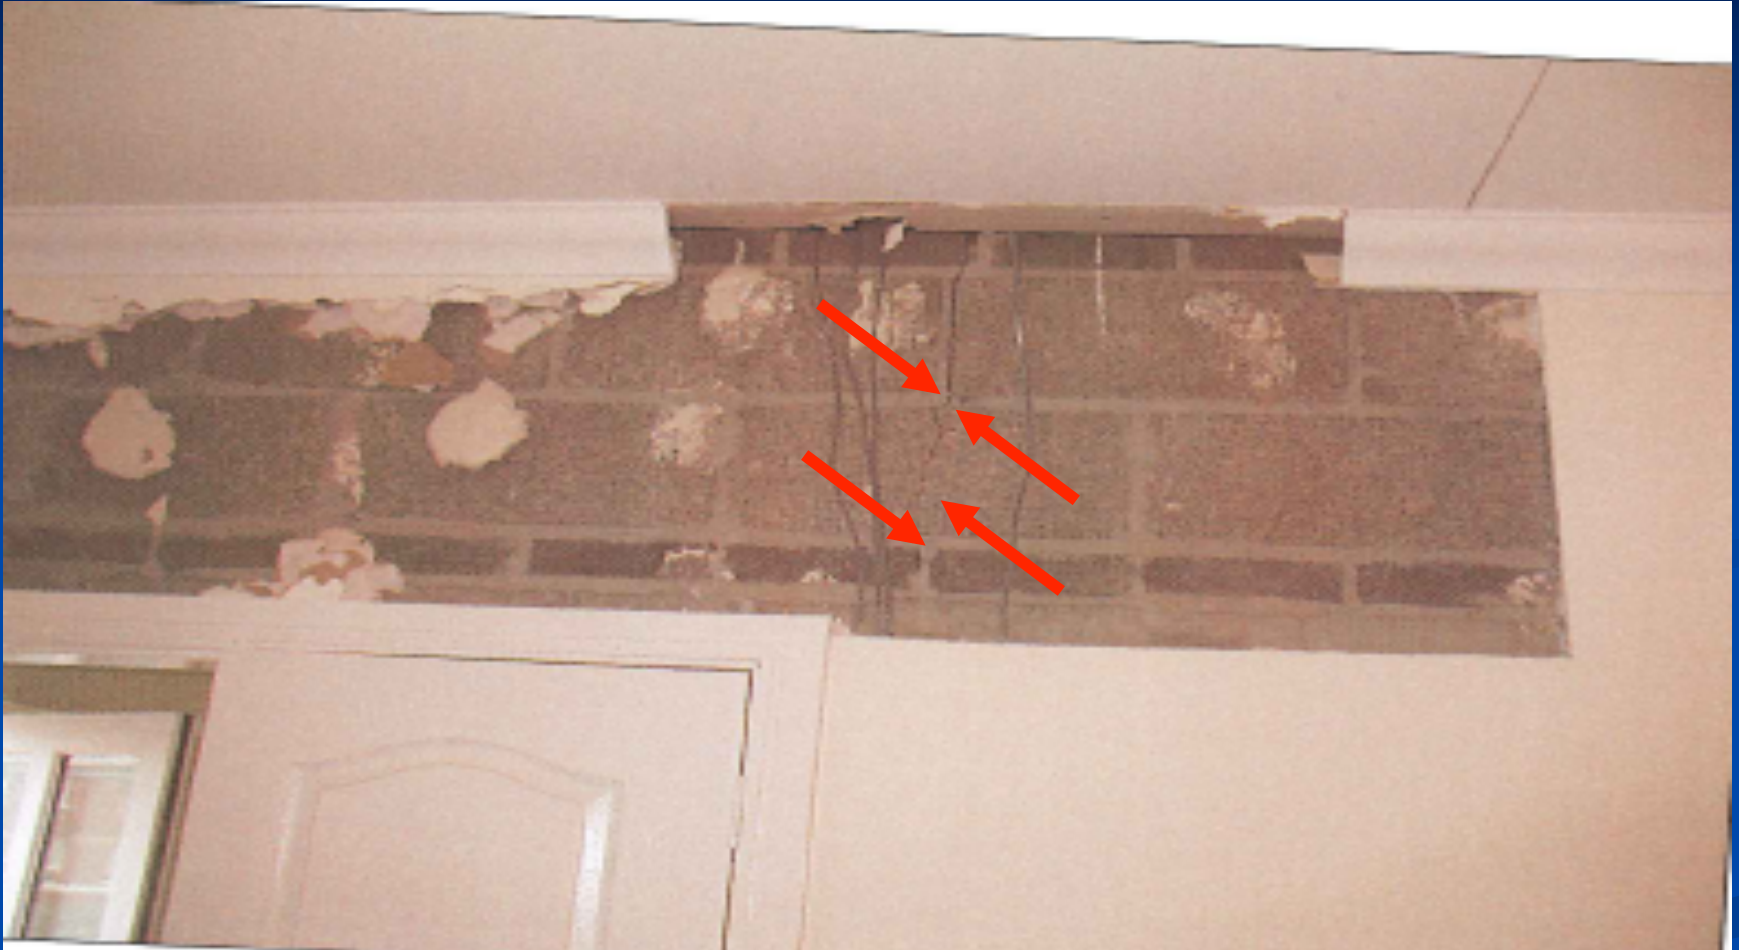
Photo shows the cracking in the exposed blockwork

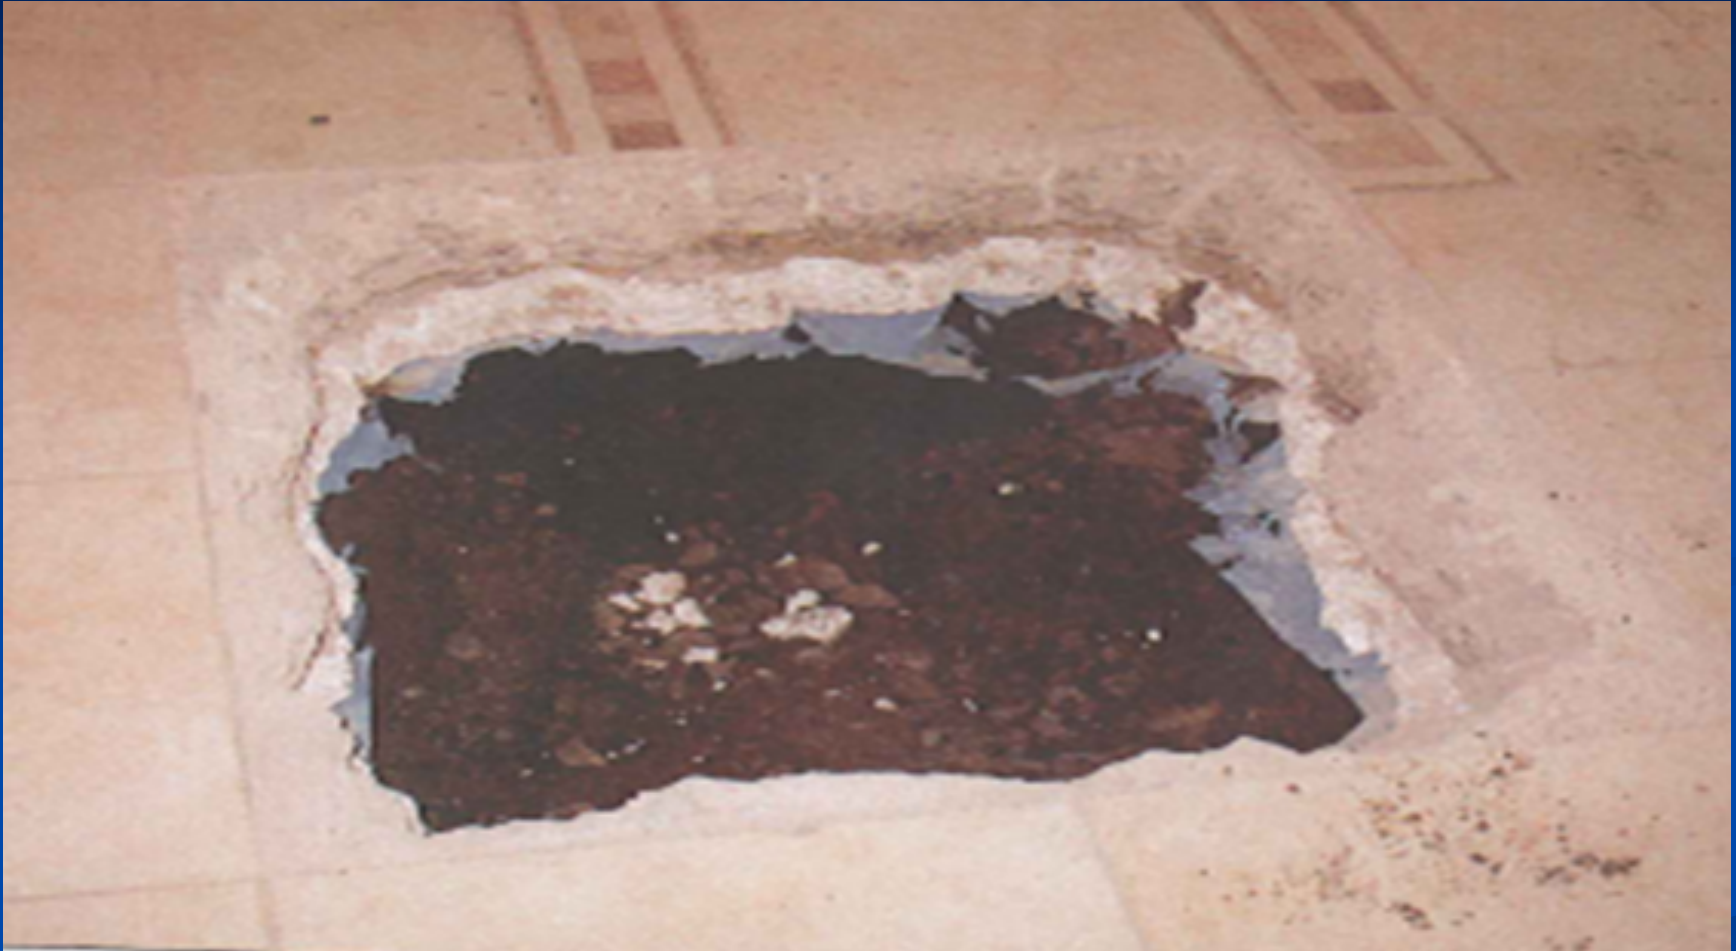
Photo shows example of a trial pit excavated to undertake sampling of the hardcore
